# Property Management Report

OnSight Inspections, 1251 East Yorba Linda Blvd, Placentia, California, 92870

2018-07-30

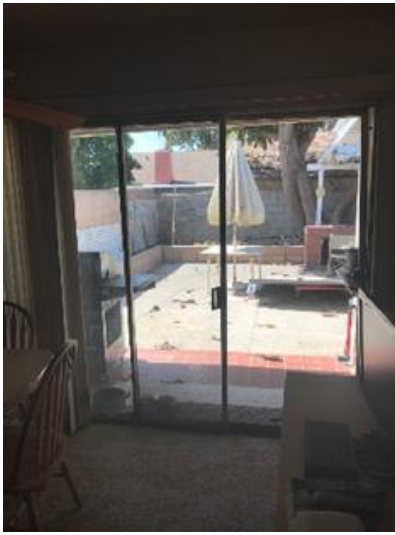
| Window/Lock/Screen | -- ! - | Maintenance Required | Needs to be rescreened and have wheels installed |

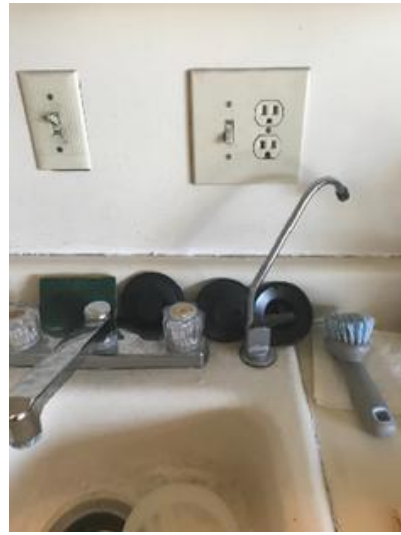
| Switch/Outlet | - - ! - | Maintenance Required | Needs to be GFI |

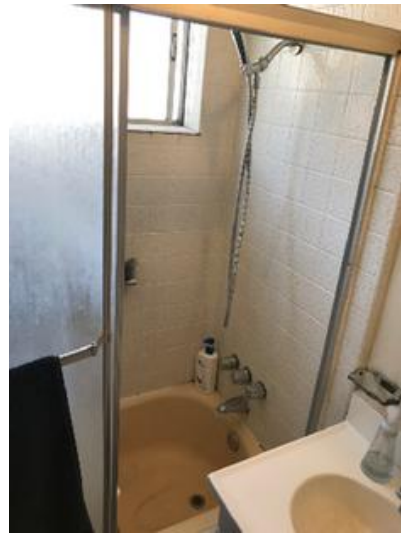
| Bathroom 1 | CONDITION | ACTION | COMMENTS |
|---|---|---|---|
| Tub/Shower | - - ! - | Maintenance Required | Needs a recaulking |

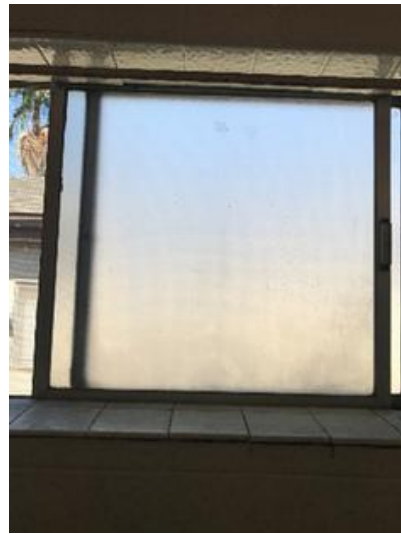
| Bathroom 1 | CONDITION | ACTION | COMMENTS |
|---|---|---|---|
| Window/Lock/Screen | - - ! - | Maintenance Required | New window screen required |

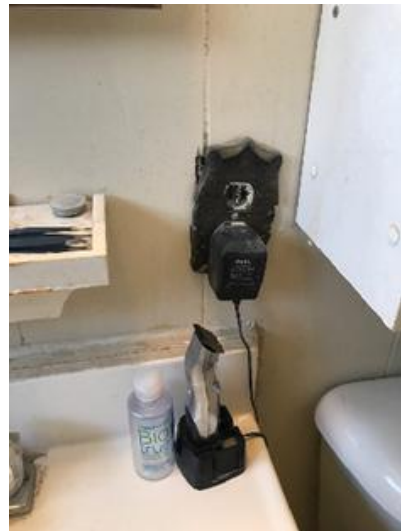
| Bathroom 1 | CONDITION | ACTION | COMMENTS |
|---|---|---|---|
| Switch/Outlet | - - ! - | Maintenance Required | Needs to be changed to GFI |

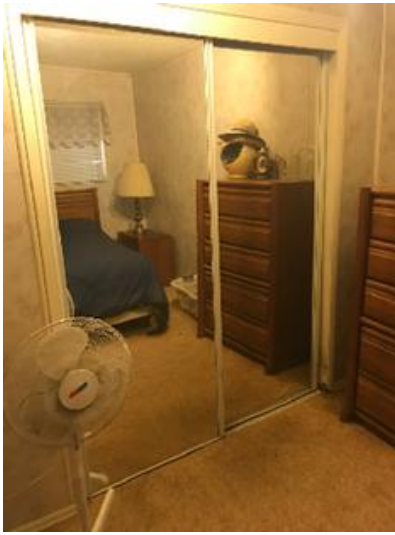
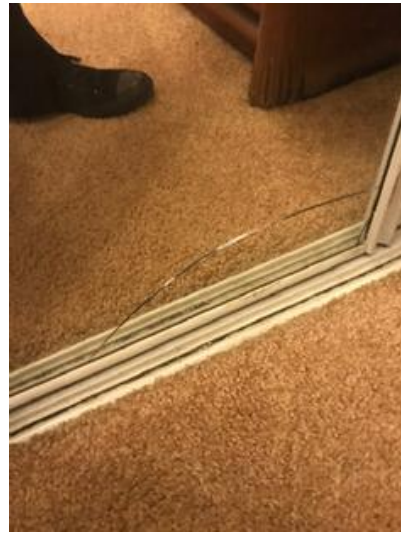
| Bedroom 2 | CONDITION | ACTION | COMMENTS |
|---|---|---|---|
| Closet/Door/Track/Shelving | -- ! - | Maintenance Required | Crack in mirror. Back of closet has drywall damage. Not necessary to repair |

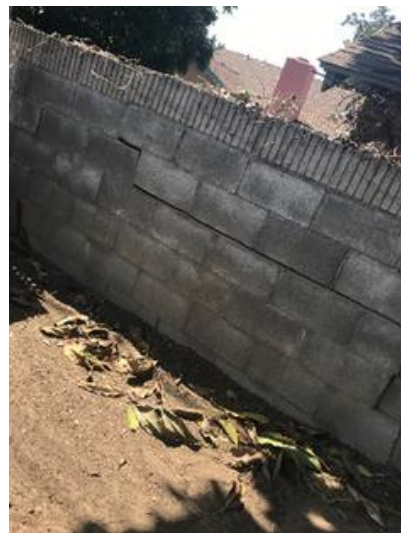
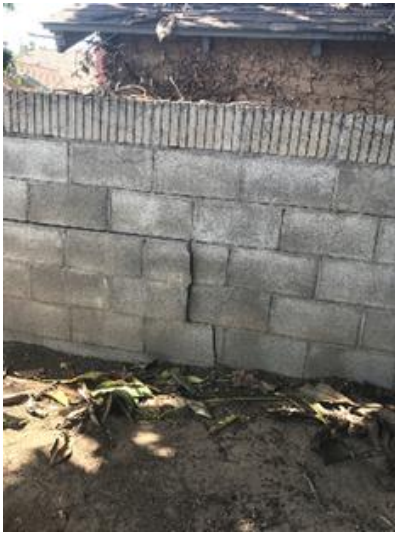
| Back Yard/Exterior | CONDITION | ACTION | COMMENTS |
|---|---|---|---|
| Fence/Gate | - - - - | Other - See Comments | |

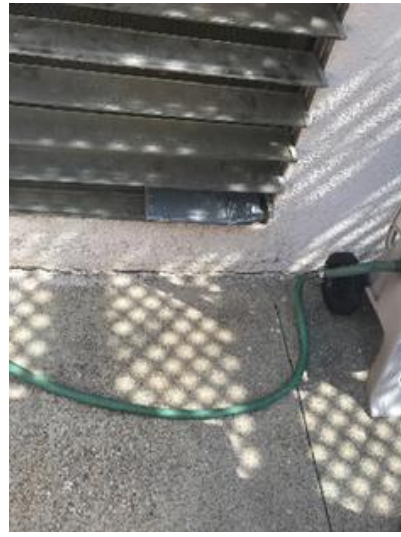
| Back Yard/Exterior | CONDITION | ACTION | COMMENTS |
|---|---|---|---|
| Building Exterior | - S - - | None | Back of wall is cracked and leaning. No concern since it has been like that for years from what the tenant told me |
