Sun Coast Marine
Surveying and Consulting

Marine Survey Report For Sample Report
"2012 Beneteau 46 Oceanis"

XX-XXX 2012 Beneteau 46 Oceanus

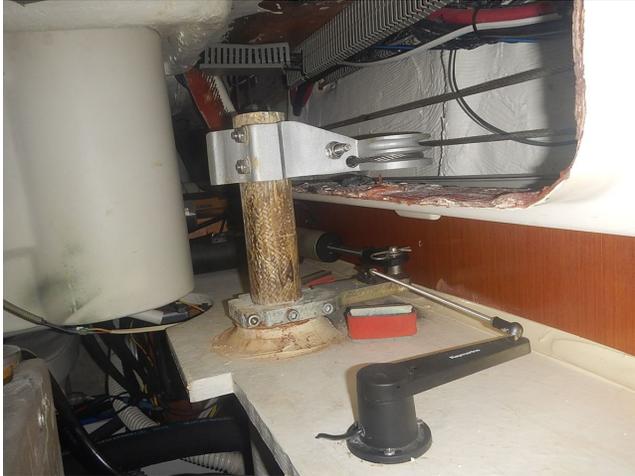
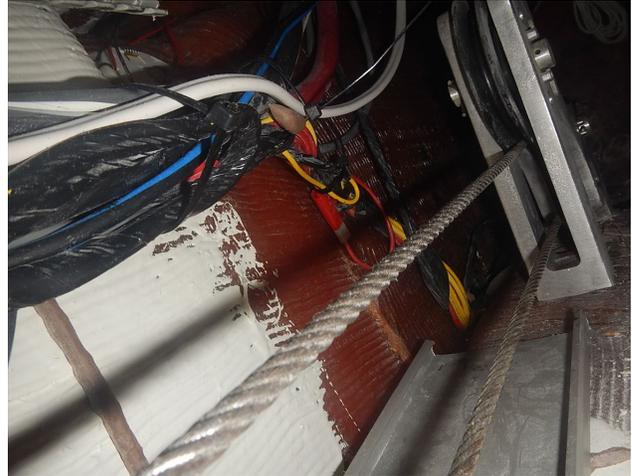
FINDING B-5

Twin wheel steering, mounted on pedestals molded into part of cockpit, pedestal mounted cable type radial quadrant drive at rudder head. Cable and dogs appeared to be in serviceable condition with no indication of corrosion sighted. Auto pilot sensor attached and in serviceable condition. Spade rudder in serviceable condition, however there is some movement of the lower bearing.

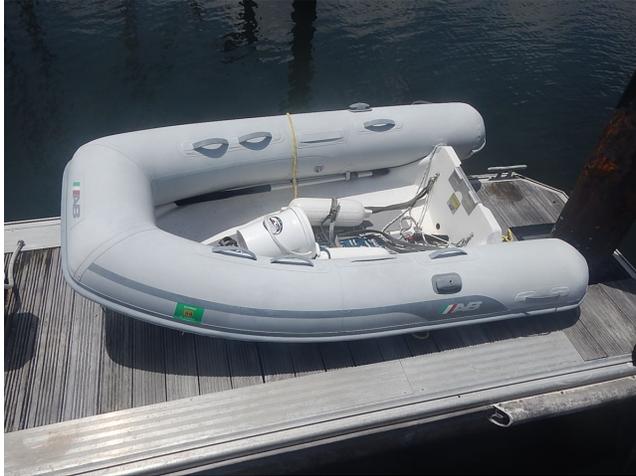
AB inflatable with hard bottom, approx. 8ft in length. Yamaha 4 stroke outboard. Appear in good serviceable condition.

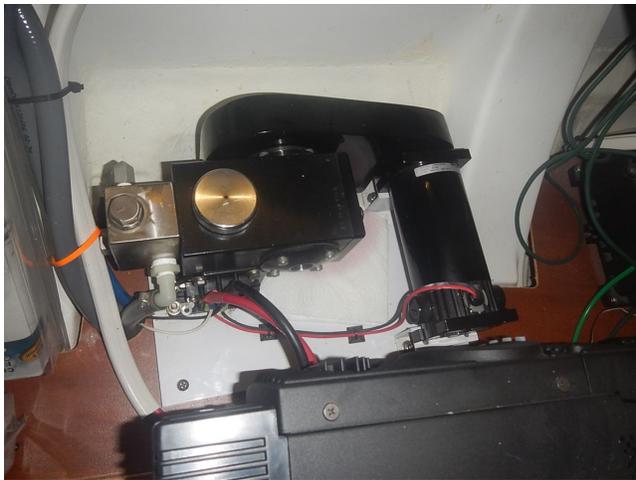
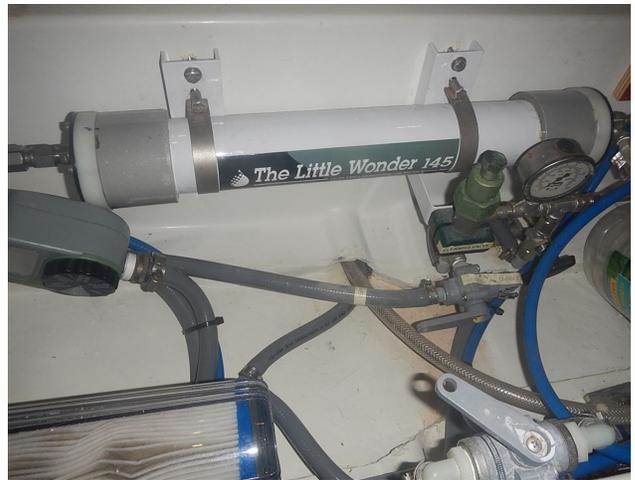
The Little Wonder 145 by Parker water maker installed by the salon floor and starboard side salon seat. Not tested. Watermakers are typically very sensitive units. Owners manual must be read and fully understood before testing/using the unit.
