# Property Management Report

OnSight Inspections, 1251 East Yorba Linda Blvd, Placentia, California, 92870

2018-07-30

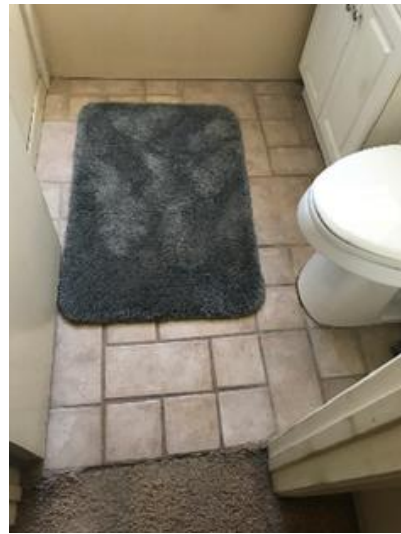
Flooring/Baseboard  
 Taken on: 2018-07-30 10:31:10  
 Taken at: [33.8723454569, -117.90377682](#)  
[Image](#)
