Sun Coast Marine
Surveying and Consulting

Marine Survey Report For Sample Report
"2012 Beneteau 46 Oceanis"

XX-XXX 2012 Beneteau 46 Oceanus

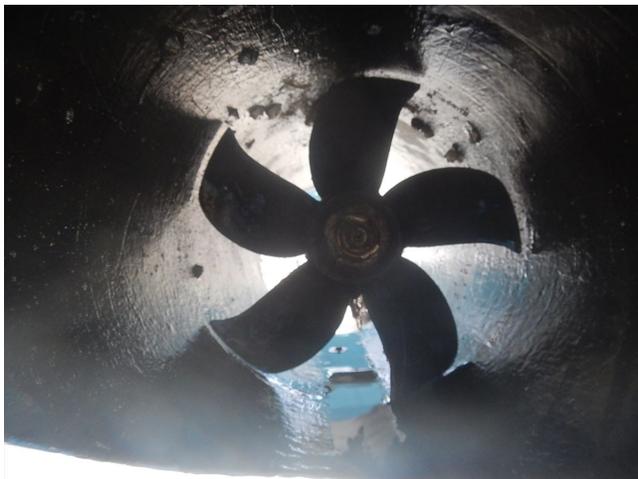
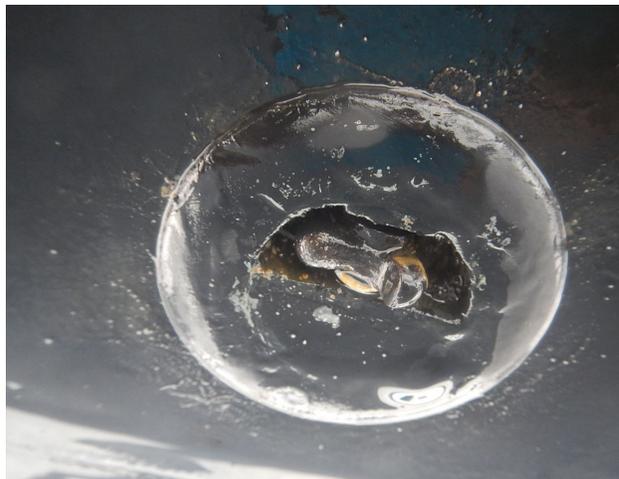
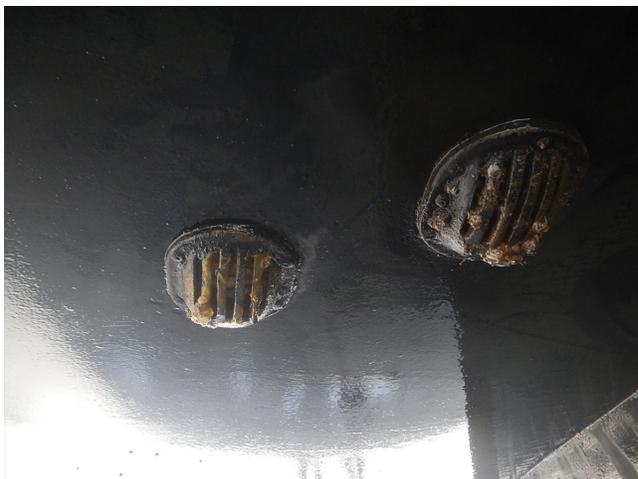
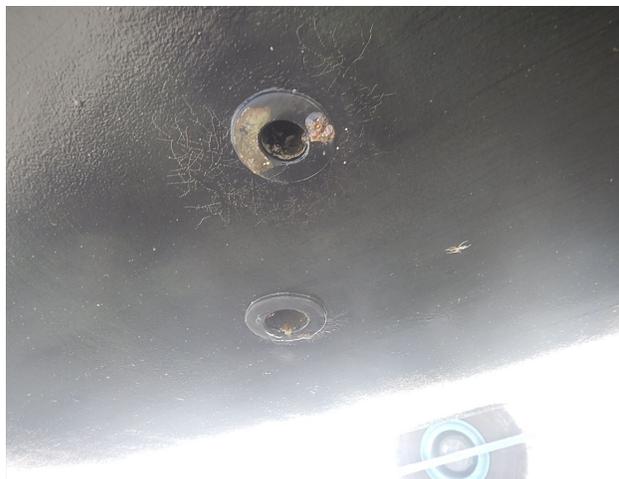
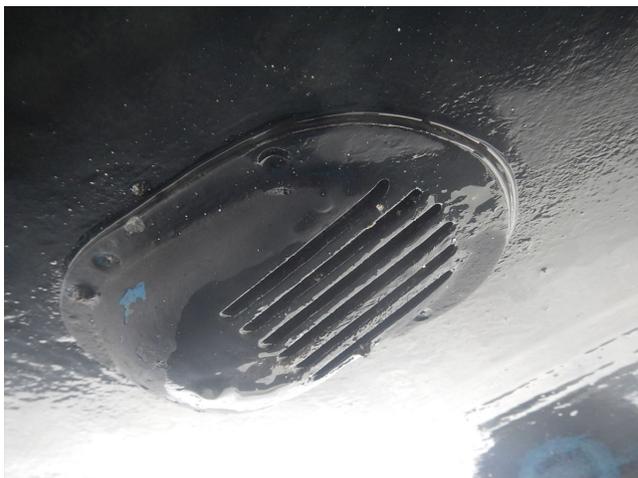
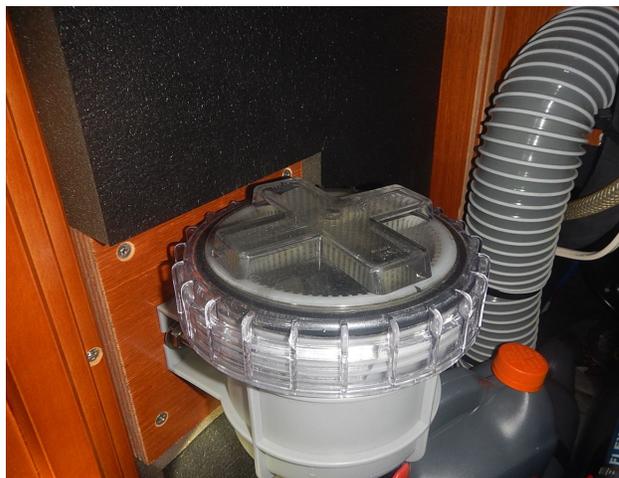
Bronze fittings that appear to be in serviceable condition showing average wear and tear for the age of the vessel and secure.

Bronze slot style thru hull strainer covers, appear to be in serviceable condition with limited wastage.

Bronze sea cocks with mounting flanges. Valves were exercised and found to be functional.

Lewmar bow thruster installed. Propeller blade in serviceable condition. Tunnel in serviceable condition. Controls at starboard side helm not fully functional.

This company suggests the sea cock/ sea valves be serviced according to the manufactures recommendations as a preventative measure upon purchasing a used vessel and thereafter as recommended by the sea cock/ sea valve manufacturer or more frequently as a part of the vessel's regular maintenance program. We also strongly recommend that if the vessel is left unattended that all below waterline sea valves be closed with the exception of scuppers, bilge pump discharge, or other valves that are required to be in the open position to prevent flooding of the vessel during inclement weather. This provides an extra measure of safety for the vessel as well as the added benefit of familiarizing the crew with safety valve locations and to exercise the valves to prevent seizure. Moreover, if not already done so, it is strongly suggested that properly sized tapered wooden plugs be kept in the vicinity of each sea cock/sea valve/thru hull to be used as a plugging device in the case of an emergency. Finally, when renewing the vessels protective coatings, it must be kept in mind that antifouling paints containing copper or other metals must not be applied to metal fittings and/or machinery without first having an insulated coating such as underwater metal primer or epoxy barrier coat applied. Failure to do so can result in harmful galvanic corrosion damage to the fittings and/or machinery.

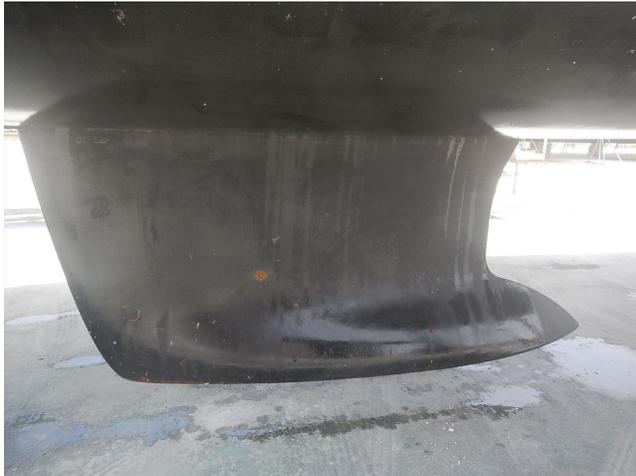
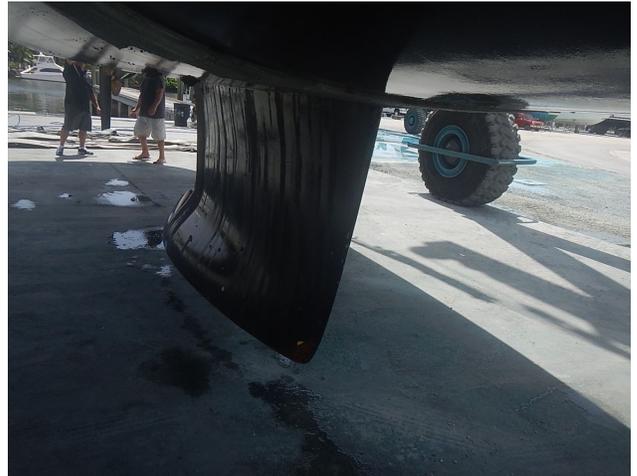
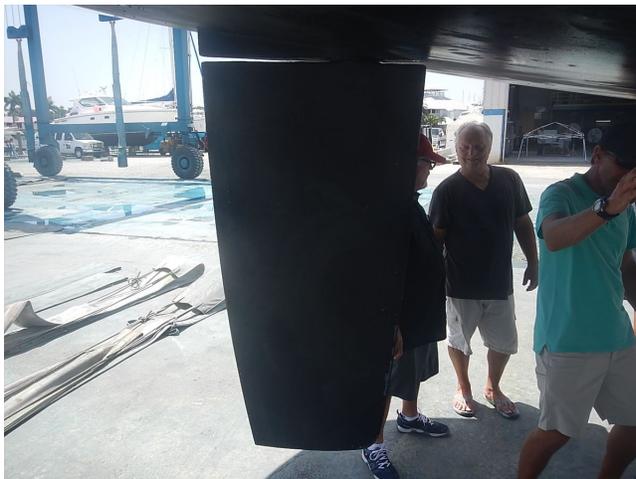
Keel is well secured and well faired into hull. No cracks or separation sighted at hull to keel joint.

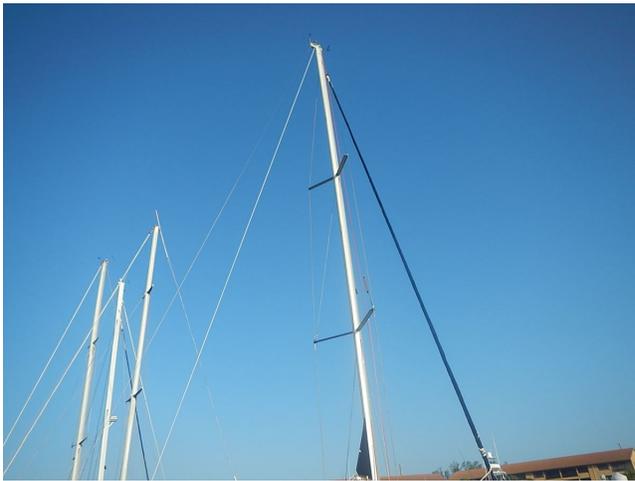
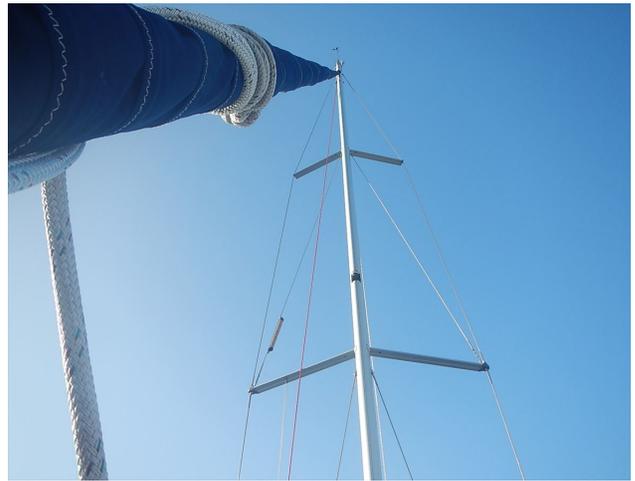
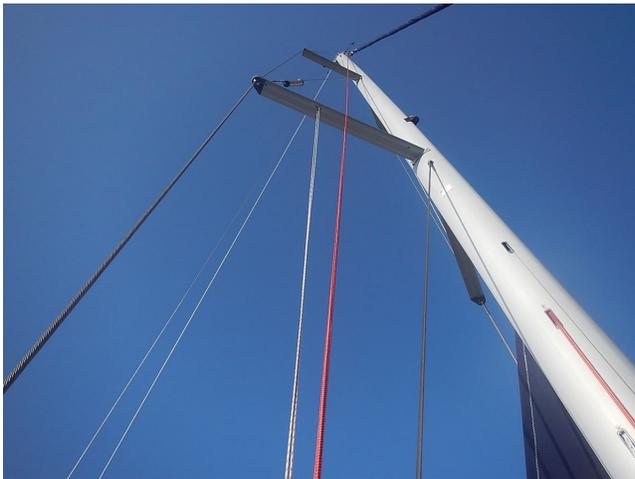
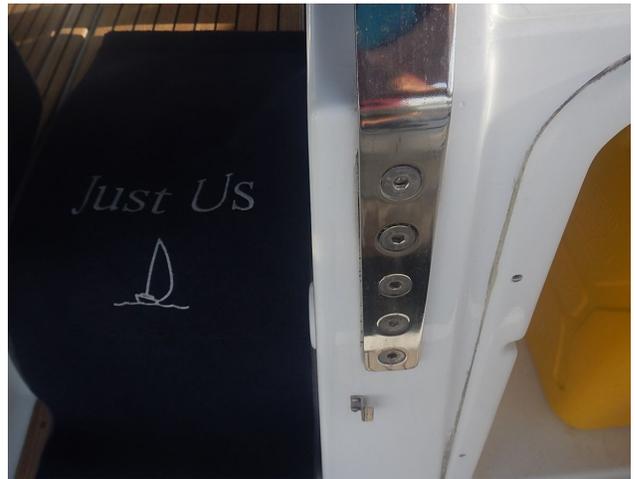
Deck stepped anodized aluminum mast with double aluminum blade spreaders, anodized aluminum boom. The spars poles, and post were inspected from deck level to a height of approx. 8 feet above deck level with the compression post bulkhead inspected as available down below. All were found to be in satisfactory condition without signs of damage and exhibited negligible to low wear and wastage.

Roller furling headstay, upper shrouds, lower shrouds and backstay. Thru deck style stainless steel shroud chain plates supported below deck by stainless steel fasteners and plates to the internal grid unit. Stainless steel flat bar chain plates thru bolted to the outside of the stern. The chain plates were examined visually where normally accessible and no anomalies were observed. In apparent serviceable condition.

Roller furling foresail and in mast furling main installed. All in serviceable condition.

Weather deck mounted aluminum T Track style genoa tracks cars. Firmly mounted and serviceable showing negligible wear and tear.

We suggest that all furling gear be serviced according to the manufacture' s recommendation upon the purchase of a used vessel as a preventative measure.

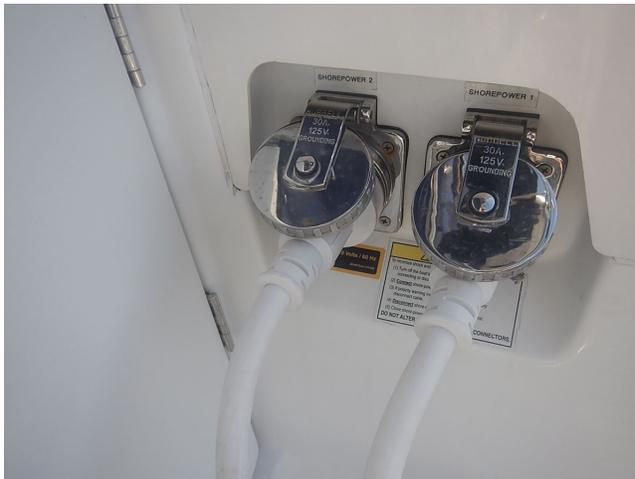
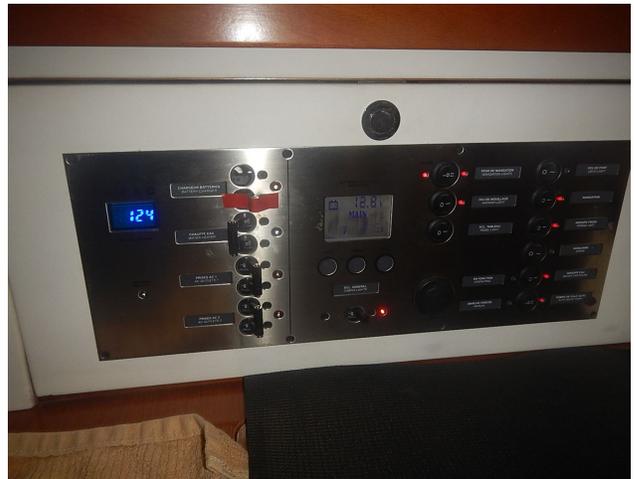
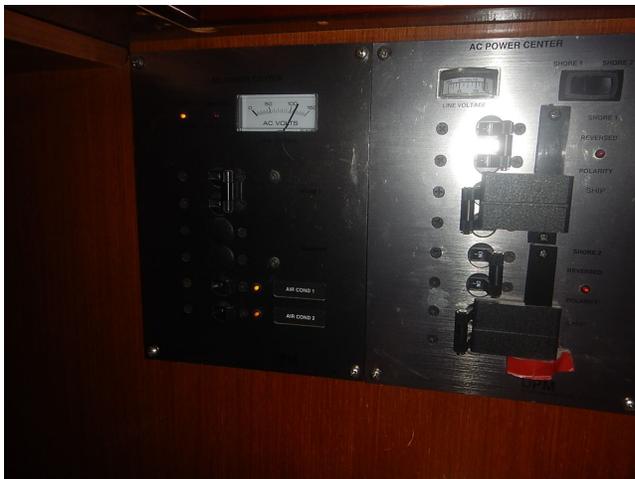
FINDING C-1

The vessel was equipped with two 120 VAc Hubbel 30 amp single phase Ac system. The vessel shore power connections were located on the starboard side of the transom deck. The operable main shore power circuit breaker is located at the AC distribution panel in the main salon. All breakers were operable and analog volt and amp gauges were installed at the power panel. Overcurrent protection was provided for with individual branch circuit breakers in addition to the main shore power circuit breaker installed on the panel board. An operable main circuit breaker was also installed at the generator, and the generator/shore power selector switch at the panelboard in the salon was an operable make or break type switch. Where accessible and visible, the shore powers system's consisted of multi-stranded copper conductors with plastic-type insulation, and the terminal's consisted of ringing terminals and butt slices. The system's wiring in so far as could be determined did not appear to be modified from its factory installation, and no indications of overheating of the visible portion's of the wiring insulation was found. The Ac panel board was fitted with reverse polarity indicators which were functioning. GFCI protected AC receptacles were installed in the vessel. The systems impedance, voltage drop, polarity and GFCI function were tested at each Ac receptacle with a Suretester device with shore power and generator supplied power and tested normal except as indicated in the Findings & Recommendations. As far as could be determined by general examination without making disassemblies, the system was found to be in apparently good working order.

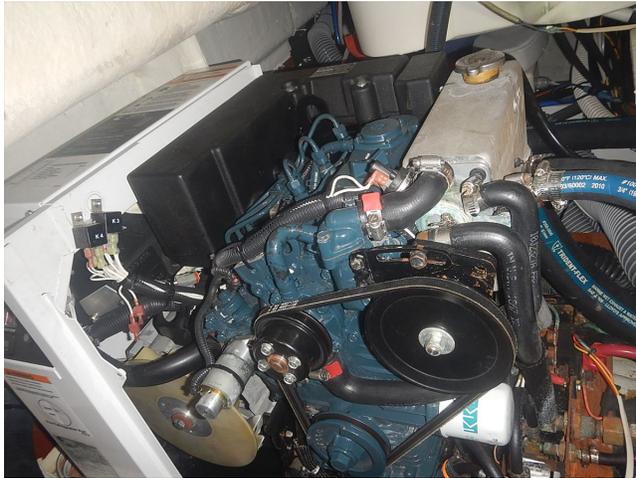
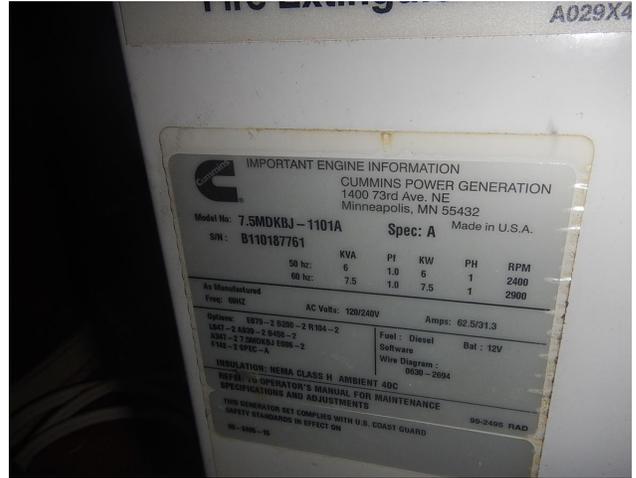
Located in the aft storage locker is a Cummins Onan 7.5KW 3 cylinder diesel generator. The generator is a freshwater cooled unit, coolant levels were full. All hoses appeared to be serviceable. The generator started and functioned by holding a full load, all air conditioning units, stove burners, oven and microwave were powered on, the generator maintained voltage.

Serial Number: B110187761

Generator Hours: 880 hrs

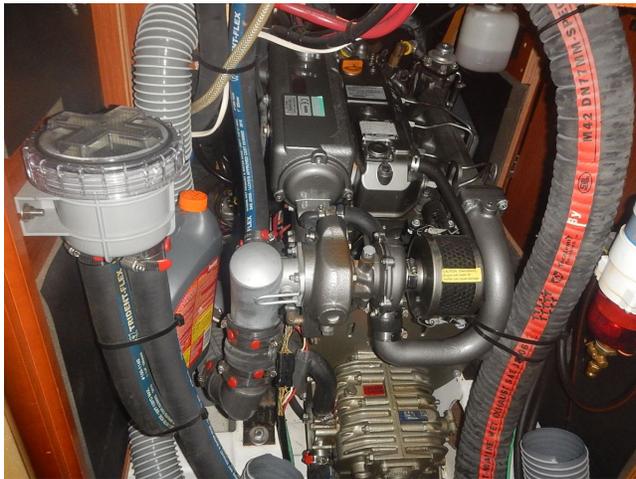
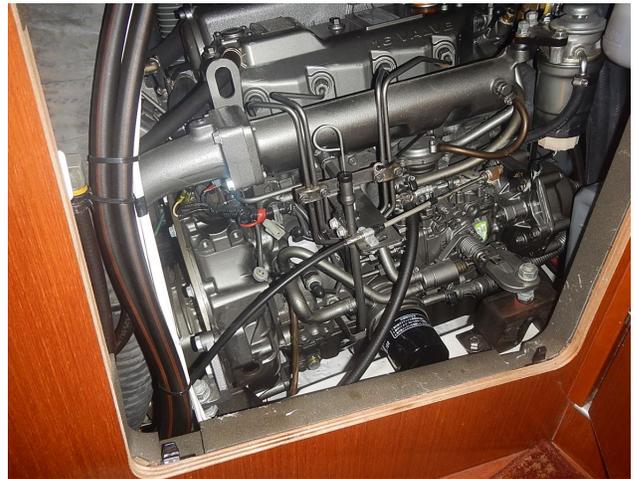
A Yanmar model 4JH4-IE 4 cylinder diesel engine with raw water cooling system and wet type of exhaust with unknown rated horse power. The engines were secured to the vessels longitudinal main stringers made fast by stainless steel engine mount fasteners. The engines cooling systems were equipped with engine mounted raw water cooling pumps and pipe with reinforced hard wall marine water hoses secured with hose clamps, engine mounted OEM type cooling system hoses secured with hose clamps and metal piping. Plastic type raw water strainers with site glass were incorporated into the raw water intake hoses, and the raw water was discharged to the exhaust at the mixing elbows. The exhaust systems were wet type with common approved type wet exhaust hoses, metal exhaust tubing and discharged to the aft thru-hull fitting. All sighted exhaust hose connections were made fast with double hose clamps per ABYC recommendations. All hoses appear to be in serviceable condition. Belt condition appears to be serviceable with no cracks or evidence of belt dust sighted. All fluid levels appeared to be full.

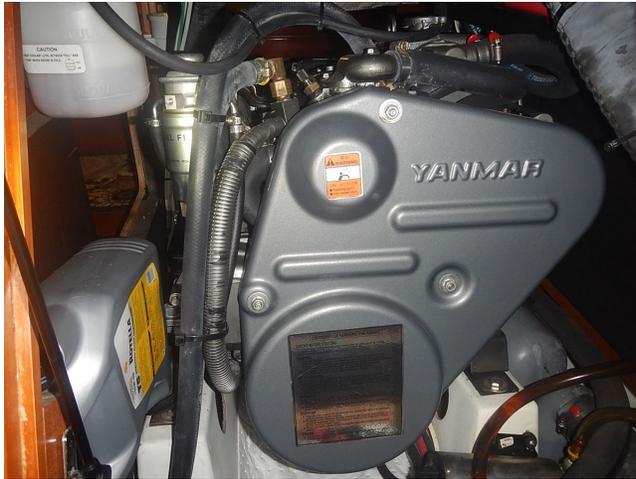
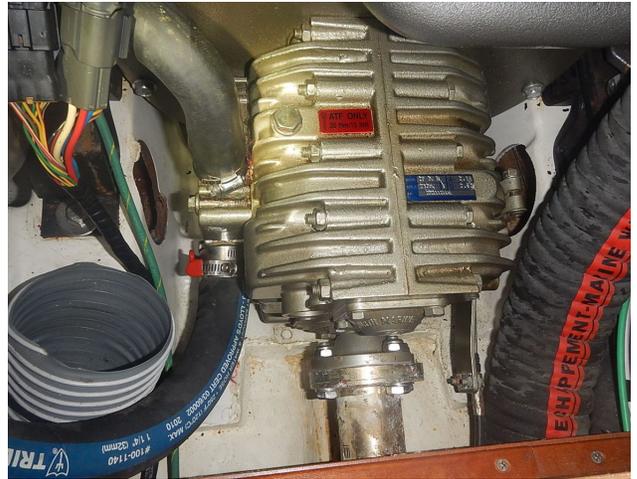
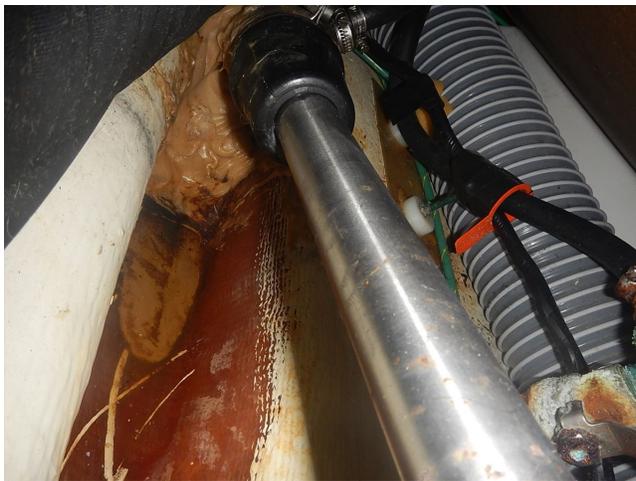
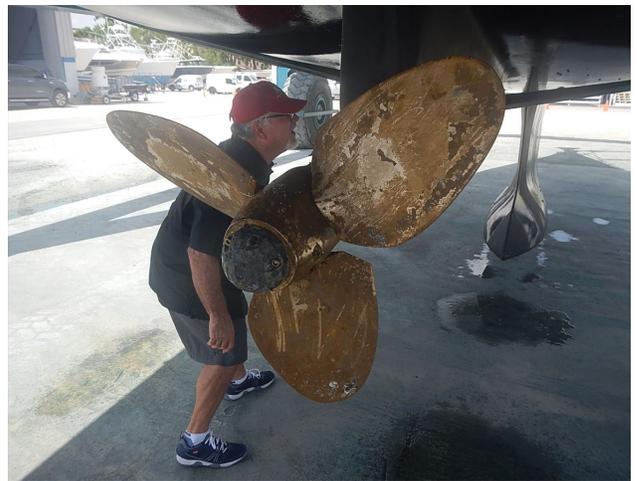
Stainless steel propeller shaft, shaft log appears to be dipless type and 3 blade feather bronze propeller. When inspected out of water no evidence of pitting, bent shafts or damaged propeller blades were observed. Feathering propeller blades moved freely.
