# Property Management Report

OnSight Inspections, 1251 East Yorba Linda Blvd, Placentia, California, 92870

2018-07-30

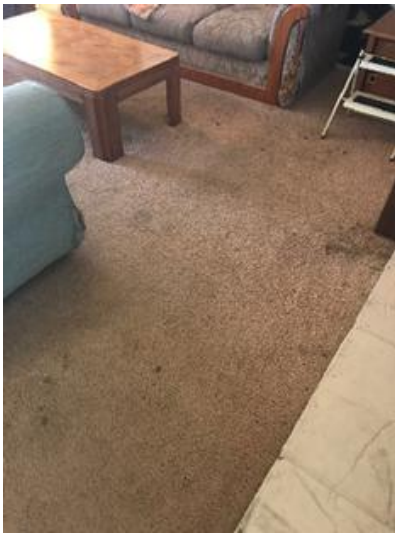
| Living Room | CONDITION | ACTION | COMMENTS |
|---|---|---|---|
| Flooring/Baseboard | - - ! - | Cleaning Required | |

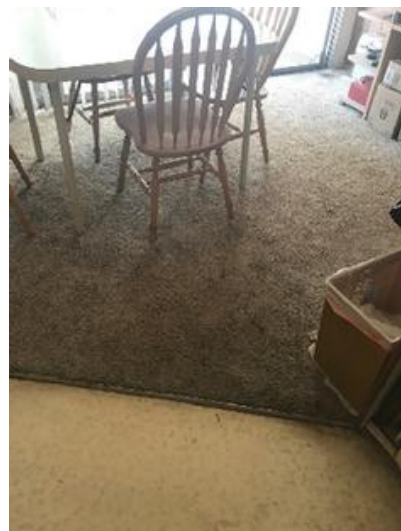
| Flooring/Baseboard | -- ! - | Cleaning Required | |

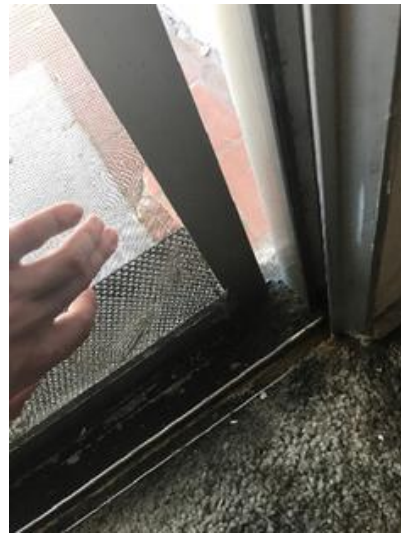
| Window/Lock/Screen | -- ! - | Maintenance Required | Needs to be rescreened and have wheels installed |

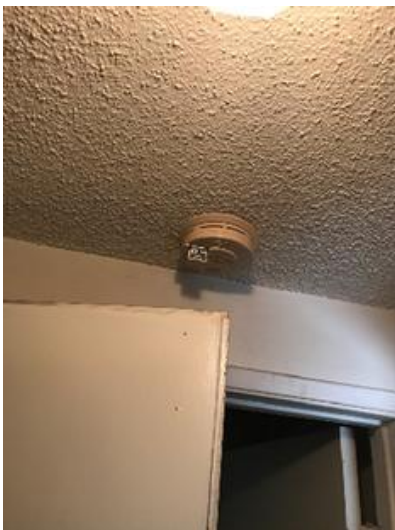
| Smoke/CO Detector | - - ! - | Maintenance Required | No CO2. Battery died. Tenant threw it away |

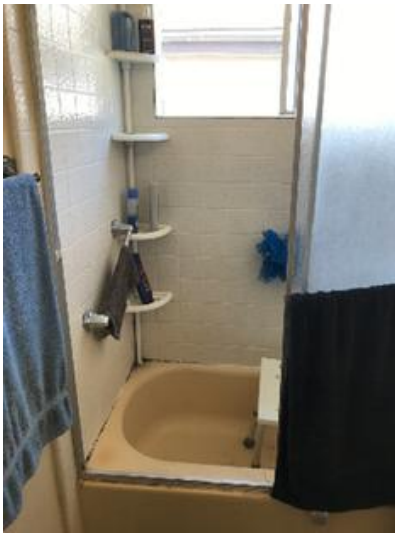
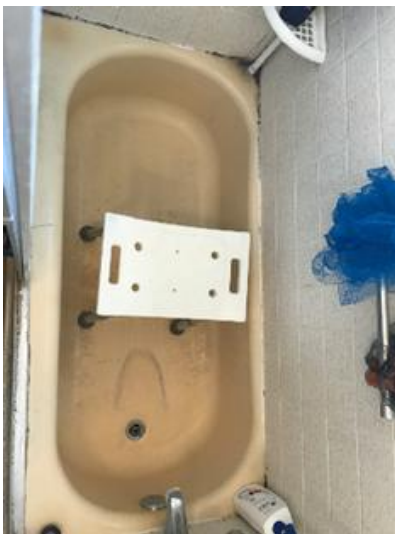
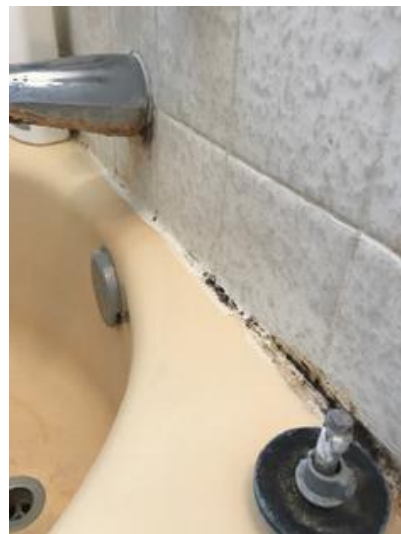
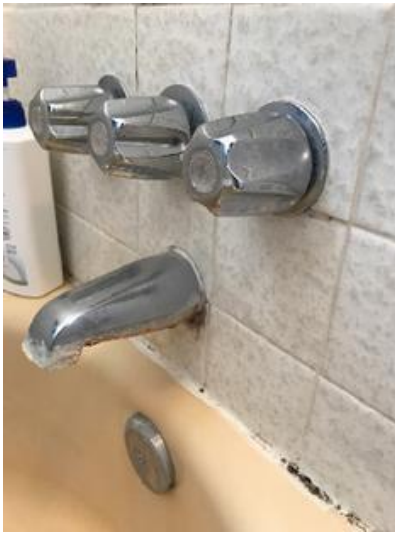
| Bathroom 1 | CONDITION | ACTION | COMMENTS |
|---|---|---|---|
| Tub/Shower | - - ! - | Maintenance Required | Needs a recaulking |

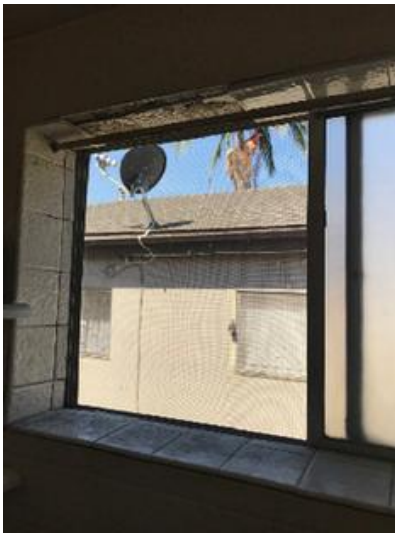
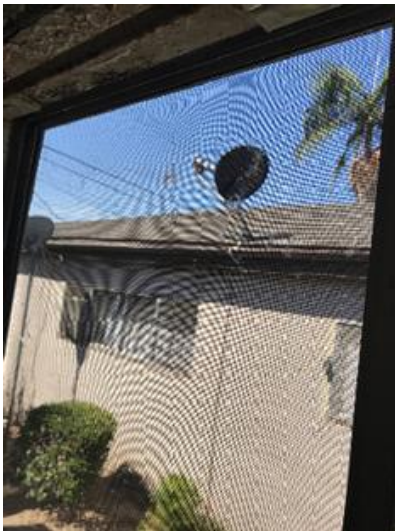
| Bathroom 1 | CONDITION | ACTION | COMMENTS |
|---|---|---|---|
| Window/Lock/Screen | - - ! - | Maintenance Required | New window screen required |

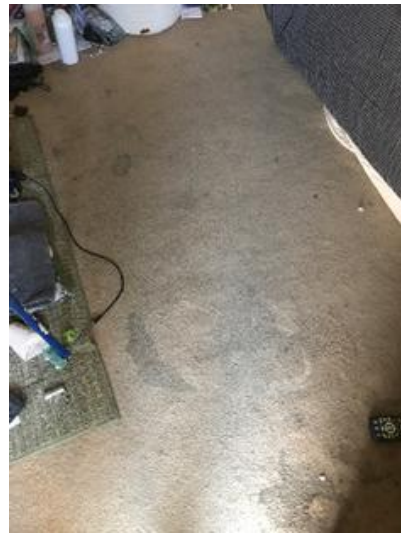
| Bedroom 1 | CONDITION | ACTION | COMMENTS |
|---|---|---|---|
| Flooring/Baseboard | - - ! - | Cleaning Required | |

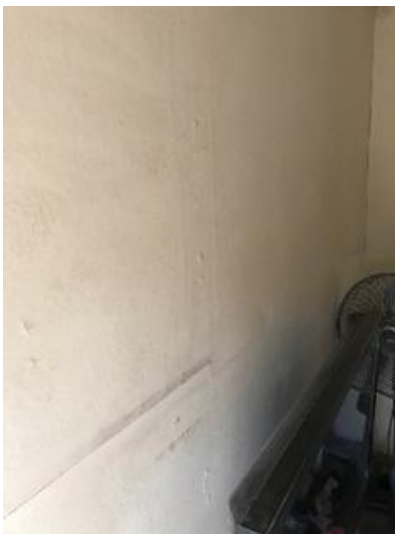
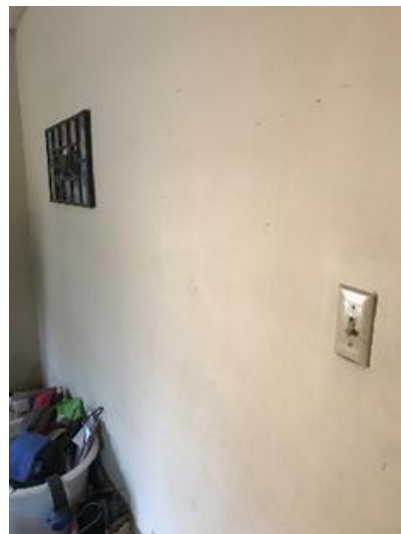
| Bedroom 1 | CONDITION | ACTION | COMMENTS |
|---|---|---|---|
| Wall/Ceiling | - - ! - | Cleaning Required | |

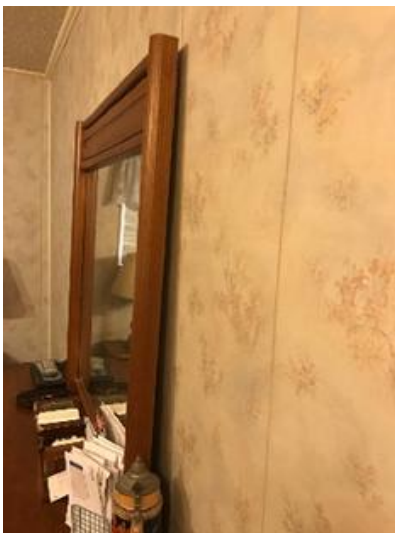
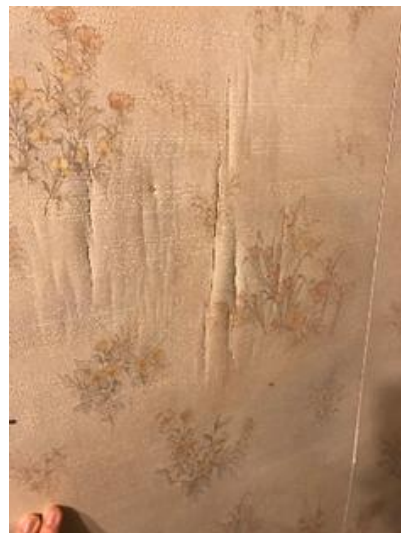
| Bedroom 2 | CONDITION | ACTION | COMMENTS |
|---|---|---|---|
| Wall/Ceiling | - - ! - | Maintenance Required | |
